Landslides at Beachy Head, Sussex

As part of a programme of work monitoring coastal erosion and landsliding at several sites around the coast of Great Britain, BGS has surveyed the cliffs at Beachy Head in Sussex using terrestrial LiDAR — see [Terrestrial LiDAR Survey Techniques](#)

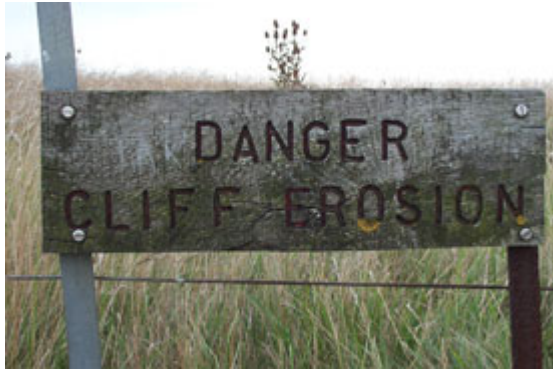
On the foreshore, the chalk platform is littered with debris aprons from recent and earlier rockslides and rockfalls. The dominant landslide mechanism is a type of sliding failure with a very deep tension crack penetrating most of the Seaford Chalk Formation. This mechanism is described in Duperret et al. (2004) as being characteristic of cliffs in the Seaford Chalk and Lewes Nodular Chalk formations in England and their equivalents in France due to the prominent vertical and sub-vertical joint and fault patterns within these formations.

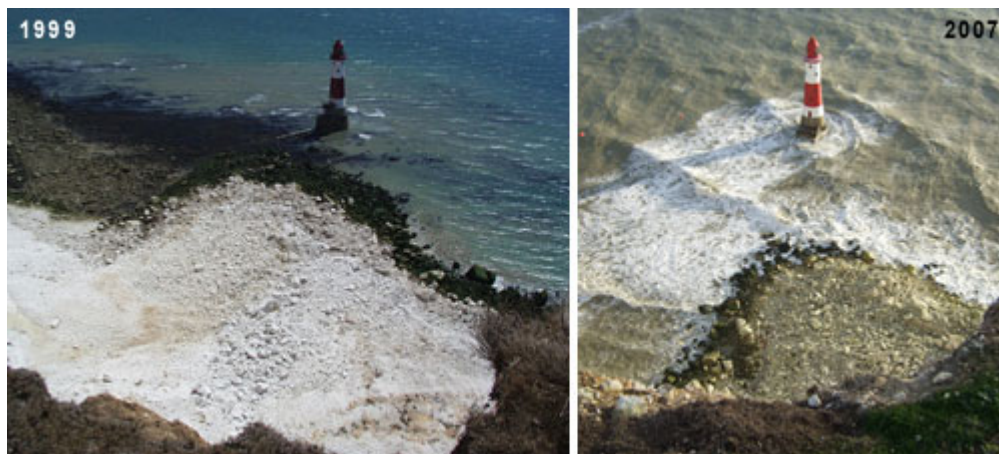
Figure 3 January 1999 landslide debris apron. Photographed July 1999 (left) and October 2007 (right) showing how the debris apron is still present after several years of erosion.

On the night of 10 January 1999, a large landslide occurred at Beachy Head severing power and telecom cables from the cliff top bunker to the lighthouse. For several months, the failure required emergency manning procedures by Trinity House Lighthouse Service. The volume of this landslide is estimated to have been $128\,000\text{m}^3$ (Hobbs et al., 1999) and between $100\,000$ and $150\,000\text{m}^3$ (Mortimore et al., 2004). This landslide produced a large debris apron (Figure 2), which persists to the present day.

The lighthouse base is situated at approximately 192 m from the cliff toe at high tide. The debris apron extended originally about 115 m from the cliff toe and came within 65 m of the lighthouse. The cliff at this point is 126 m high.

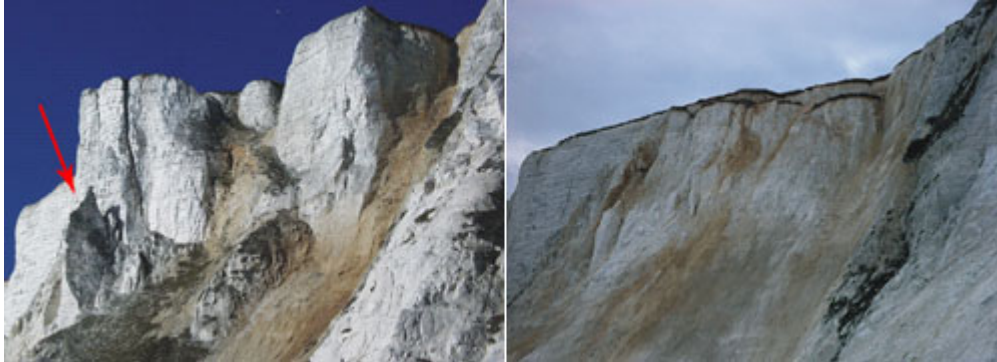
Figure 4 Devil's Chimney before (left) and after (right) the landslide

This landslide occurred at 14.30hrs on 3 April, 2001 and destroyed the landmark known as the 'Devil's Chimney' (Figures 3 and 4). The landslide followed three days of preliminary subsidence and detachment movements amounting to a displacement of a few metres.

A deep tension crack, probably penetrating the entire thickness of the Seaford Chalk Formation, developed following pre-existing joints. The separated block tilted seaward further opening the tension crack and increasing the vertical stresses at its base. Debris and water were able to enter the fissure over many years, before the final slide where failure occurred. This failure is thought to have occurred in two stages separated by a few days or hours.

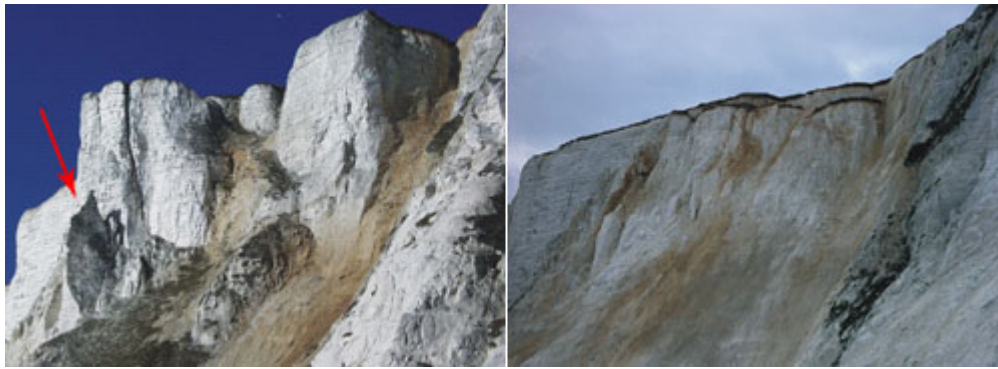
Devil's Chimney before (left) and after (right) the landslide.
